**Flood Control Project Maintenance
Levee Inspections**

Maintenance Issue Types Only, Levee Inspection Report By Mile - Spring 2016

Levee District No. 0002 (Glenn County)

Waterway	Bank	Unit Miles	Inspection Start/End	Inspector
Unit No. 01 Glenn County Sacramento River	Right	4.90	04/22/2016 04/22/2016	Keith Millard

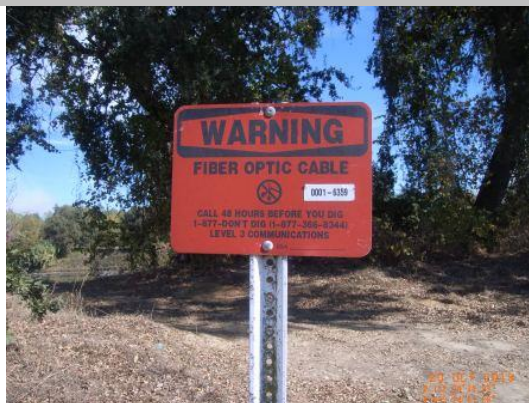
Photo 2 of 2 : SP_2016_LD0002_28_6_20160420_00006.jpg

LM Start	0.07	Rating **	M	Issue No.	6 (cont)
LM End	0.28	Issue Type +	Ma	Location *	WS

USACE 2013 Photo #2

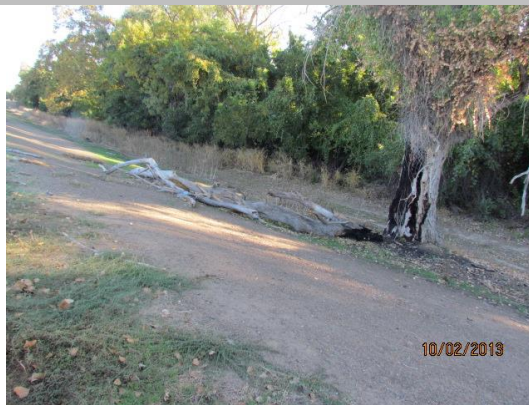
Photo 1 of 2 : SP_2016_LD0002_28_40_20160420_00018.jpg

View of the downed tree limb along the slope of the levee.

LM Start	1.24	Rating **	M	Issue No.	40
LM End	1.24	Issue Type +	Ma	Location *	WS
Category	Earthen Levee			GPS Latitude/Longitude	
				Start	End
Item	Encroachments			39.431499 °	39.431499 °
				-122.010803 °	-122.010803 °
DWR ID	DWR_LD0002_01_f_2013_40				
Comment Code					
TR : Tree or limb					
Inspector Comment					
Remove the tree limbs from the waterside slope.

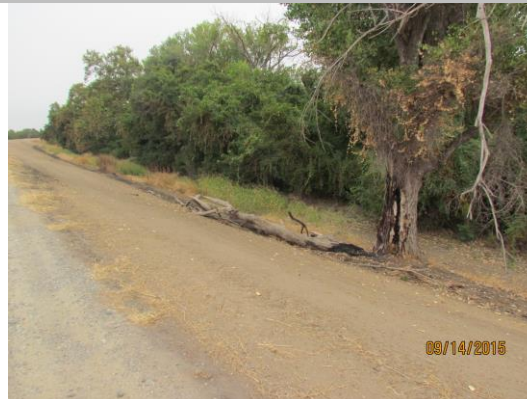
Photo 2 of 2 : SP_2016_LD0002_28_40_20160420_00019.jpg

View of the tree limbs along the waterside slope.

LM Start	1.24	Rating **	M	Issue No.	40 (cont)	
LM End	1.24	Issue Type +	Ma	Location *	WS	
Category	Earthen Levee			GPS Latitude/Longitude		
				Start		End
Item	Encroachments			39.431499 °		39.431499 °
				-122.010803 °		-122.010803 °
DWR ID	DWR_LD0002_01_f_2013_40					
Comment Code						
TR : Tree or limb						
Inspector Comment						
Remove the tree limbs from the waterside slope.

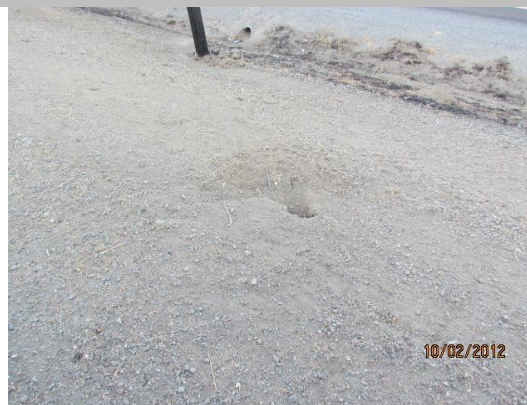
Photo 1 of 1 : SP_2016_LD0002_28_4_20160420_00003.jpg

LM Start	1.43	Rating **	M	Issue No.	4
LM End	1.43	Issue Type +	Ma	Location *	LS
Category	Earthen Levee			GPS Latitude/Longitude	
				Start	End
Item	Animal Control			39.434157 °	39.434157 °
				-122.010760 °	-122.010760 °
DWR ID	DWR_LD0002_01_f_2012_4				
Comment Code					
A3 : No rodents visible, but rodent burrows visible; need to backfill and compact or grout burrows.					
Inspector Comment

View of the rodent holes along the landside slope.

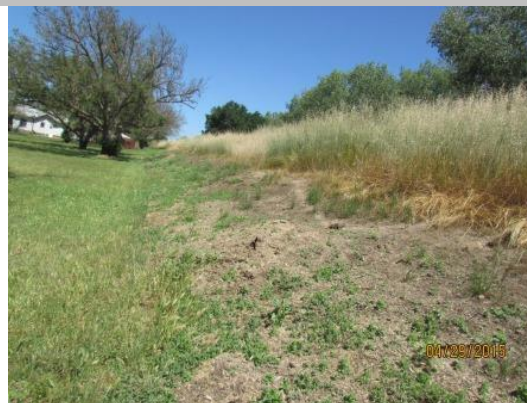
Photo 1 of 2 : SP_2016_LD0002_28_15_20160420_00013.jpg

View of the rodent holes along the landside slope.

LM Start	1.52	Rating **	M	Issue No.	15
LM End	1.60	Issue Type +	Ma	Location *	LS
Category	Earthen Levee			GPS Latitude/Longitude	
				Start	End
Item	Animal Control			39.435485 °	39.436643 °
				-122.010640 °	-122.010498 °
DWR ID	DWR_LD0002_01_f_2012_15				
Comment Code					
A3 : No rodents visible, but rodent burrows visible; need to backfill and compact or grout burrows.					
Inspector Comment					
LMA needs to repair the rodent holes.

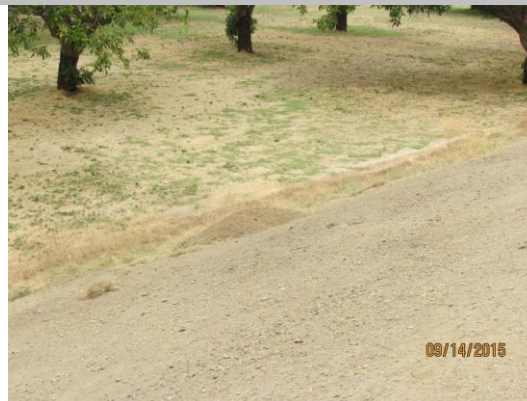
Photo 2 of 2 : SP_2016_LD0002_28_15_20160420_00014.jpg

View of the rodent holes along the landside slope.

LM Start	1.52	Rating **	M	Issue No.	15 (cont)	
LM End	1.60	Issue Type +	Ma	Location *	LS	
Category	Earthen Levee			GPS Latitude/Longitude		
				Start		End
Item	Animal Control			39.435485 °		39.436643 °
				-122.010640 °		-122.010498 °
DWR ID	DWR_LD0002_01_f_2012_15					
Comment Code						
A3 : No rodents visible, but rodent burrows visible; need to backfill and compact or grout burrows.						
Inspector Comment						
LMA needs to repair the rodent holes.

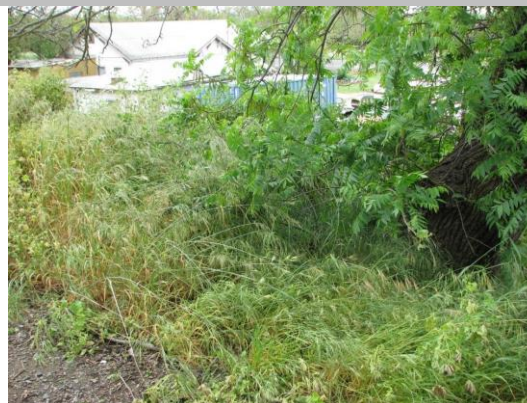
Photo 1 of 1 : SP_2016_LD0002_28_35_20160506_00053.jpg

04/22/2016: Vegetation on L/S slope

LM Start	1.63	Rating **	M	Issue No.	35
LM End	1.63	Issue Type +	Ma	Location *	LS
Category	Earthen Levee			GPS Latitude/Longitude	
				Start	End
Item	Vegetation			39.437089 °	39.437089 °
				-122.010443 °	-122.010443 °
DWR ID	DWR_LD0002_01_s_2016_35				
Comment Code					
V1 : Control annual grass and weeds on the levee slopes and easements.					
Inspector Comment

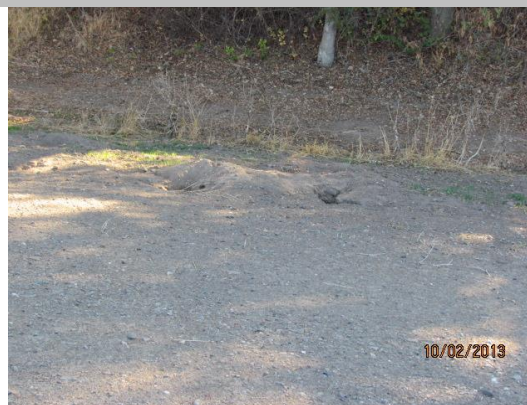
Photo 1 of 1 : SP_2016_LD0002_28_42_20160420_00021.jpg

LM Start	2.77	Rating **	M	Issue No.	42
LM End	2.77	Issue Type +	Ma	Location *	WS
Category	Earthen Levee			GPS Latitude/Longitude	
				Start	End
Item	Animal Control			39.451841 °	39.451841 °
				-122.017120 °	-122.017120 °
DWR ID	DWR_LD0002_01_f_2013_42				
Comment Code					
A3 : No rodents visible, but rodent burrows visible; need to backfill and compact or grout burrows.					
Inspector Comment

View of the rodent holes along the slope of the levee.

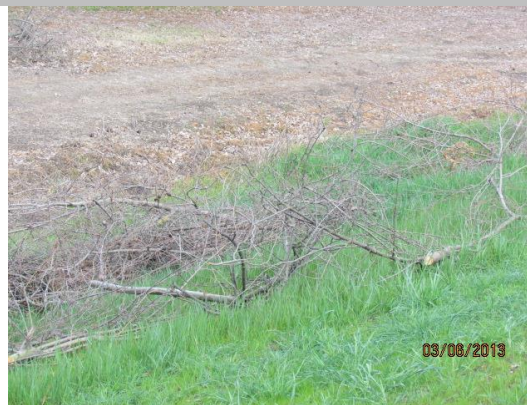
Photo 1 of 1 : SP_2016_LD0002_28_5_20160420_00004.jpg

LM Start	2.89	Rating **	M	Issue No.	5
LM End	2.89	Issue Type +	Ma	Location *	LS
Category	Earthen Levee			GPS Latitude/Longitude	
				Start	End
Item	Encroachments			39.453490 °	39.453490 °
				-122.016457 °	-122.016457 °
DWR ID	DWR_LD0002_01_f_2015_5				
Comment Code					
PR : Prunings					
Inspector Comment

View of the prunings along the landside toe.

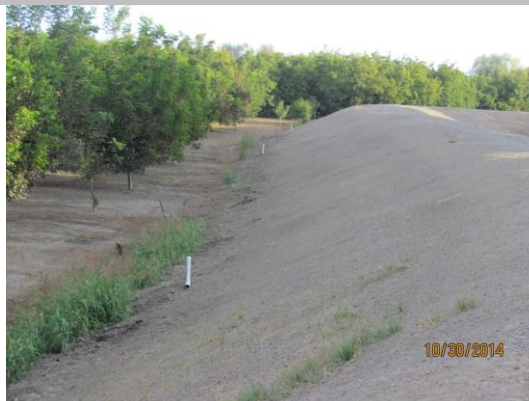
Photo 1 of 1 : SP_2016_LD0002_28_2_20160420_00001.jpg

LM Start	2.91	Rating **	M	Issue No.	2
LM End	2.96	Issue Type +	Ma	Location *	LS
Category	Earthen Levee			GPS Latitude/Longitude	
				Start	End
Item	Animal Control			39.453595 °	39.454003 °
				-122.016273 °	-122.015503 °
DWR ID	DWR_LD0002_01_f_2015_2				
Comment Code					
A3 : No rodents visible, but rodent burrows visible; need to backfill and compact or grout burrows.					
Inspector Comment

View of the rodent holes and bait station along the landside slope.

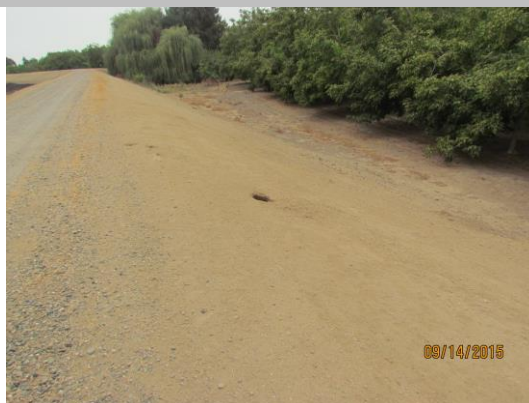
Photo 1 of 1 : SP_2016_LD0002_28_3_20160420_00002.jpg

View of the rodent holes along the waterside slope.

LM Start	3.06	Rating **	M	Issue No.	3
LM End	3.13	Issue Type +	Ma	Location *	WS
Category	Earthen Levee			GPS Latitude/Longitude	
				Start	End
Item	Animal Control			39.455145 °	39.455813 °
				-122.014287 °	-122.013205 °
DWR ID	DWR_LD0002_01_s_2012_3				
Comment Code					
A3 : No rodents visible, but rodent burrows visible; need to backfill and compact or grout burrows.					
Inspector Comment					
Repair the rodent holes along the waterside slope.

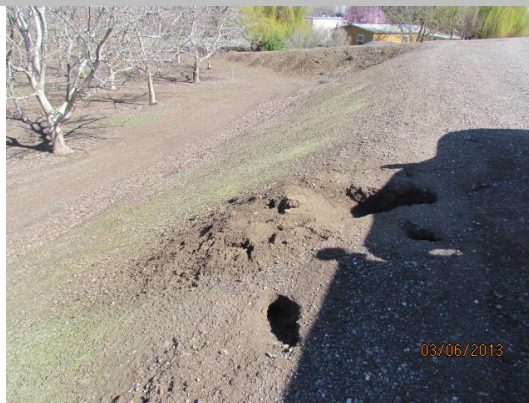
Photo 1 of 1 : SP_2016_LD0002_28_12_20160420_00011.jpg

View of the rodent activity along the landside slope.

LM Start	3.12	Rating **	U	Issue No.	12
LM End	3.17	Issue Type +	Ma	Location *	LS
Category	Earthen Levee			GPS Latitude/Longitude	
				Start	End
Item	Animal Control			39.455752 °	39.456108 °
				-122.013387 °	-122.012511 °
DWR ID	DWR_LD0002_01_s_2013_12				
Comment Code					
A1 : Exterminate rodents and backfill and compact or grout burrows.					
Inspector Comment					
Repair the rodent holes along landside slope.

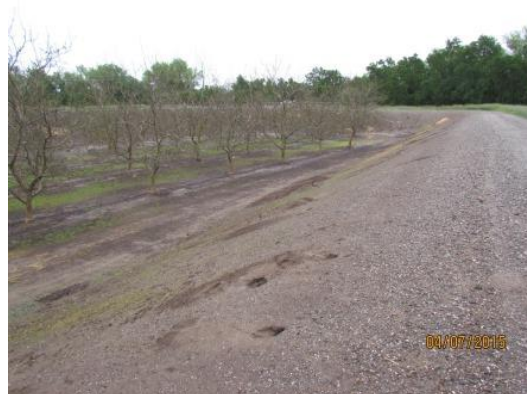
Photo 1 of 1 : SP_2016_LD0002_28_16_20160420_00015.jpg

View of the rodent holes along the landside slope.

LM Start	3.23	Rating **	M	Issue No.	16
LM End	3.30	Issue Type +	Ma	Location *	LS
Category	Earthen Levee			GPS Latitude/Longitude	
				Start	End
Item	Animal Control			39.456192 °	39.456272 °
				-122.011445 °	-122.010163 °
DWR ID	DWR_LD0002_01_f_2012_16				
Comment Code					
A3 : No rodents visible, but rodent burrows visible; need to backfill and compact or grout burrows.					
Inspector Comment					
Grout or fill the rodent holes.

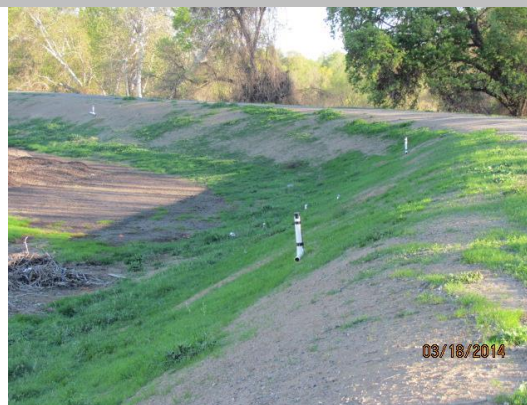
Photo 1 of 1 : SP_2016_LD0002_28_27_20160420_00016.jpg

View of the rodent activity along the l/s slope.

LM Start	3.44	Rating **	U	Issue No.	27
LM End	3.52	Issue Type +	Ma	Location *	LS
Category	Earthen Levee			GPS Latitude/Longitude	
				Start	End
Item	Animal Control			39.457692 °	39.458705 °
				-122.009517 °	-122.009872 °
DWR ID	DWR_LD0002_01_s_2014_27				
Comment Code					
A3 : No rodents visible, but rodent burrows visible; need to backfill and compact or grout burrows.					
Inspector Comment					
Repair the rodent holes on landside slope.

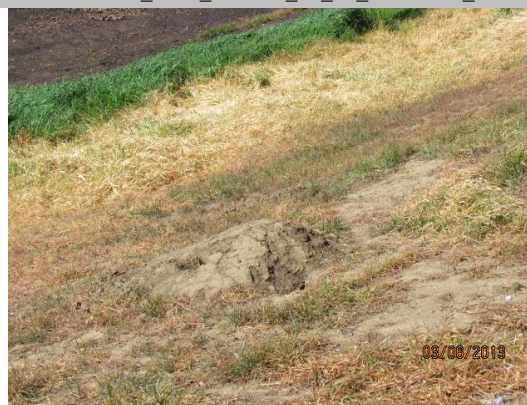
Photo 1 of 1 : SP_2016_LD0002_28_13_20160420_00012.jpg

LM Start	3.53	Rating **	U	Issue No.	13
LM End	3.57	Issue Type +	Ma	Location *	LS
Category	Earthen Levee			GPS Latitude/Longitude	
				Start	End
Item	Animal Control			39.458803 °	39.459305 °
				-122.009980 °	-122.010511 °
DWR ID	DWR_LD0002_01_s_2013_13				
Comment Code					
A3 : No rodents visible, but rodent burrows visible; need to backfill and compact or grout burrows.					
Inspector Comment

View of the rodent activity along the landside slope.

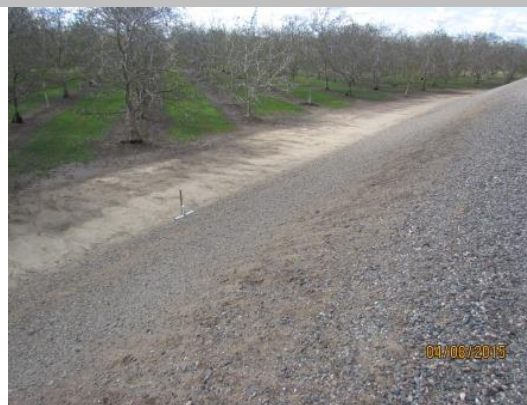
Photo 1 of 1 : SP_2016_LD0002_28_11_20160420_00010.jpg

LM Start	4.87	Rating **	A/W	Issue No.	11
LM End	4.87	Issue Type +	Ma	Location *	LS
Category	Earthen Levee			GPS Latitude/Longitude	
				Start	End
Item	Animal Control			39.476676 °	39.476676 °
				-122.017439 °	-122.017439 °
DWR ID	DWR_LD0002_01_s_2012_11				
Comment Code					
A3 : No rodents visible, but rodent burrows visible; need to backfill and compact or grout burrows.					
Inspector Comment					
The rodent holes have been filled with dirt.

View of the removed rodent holes and bait station.
